# YOUR SEWERLINE INSPECTION REPORT

# Sewer Inspection Report

LOCATED AT:  
Anytown Street

INSPECTED ON:  
Thursday, April 16, 2026

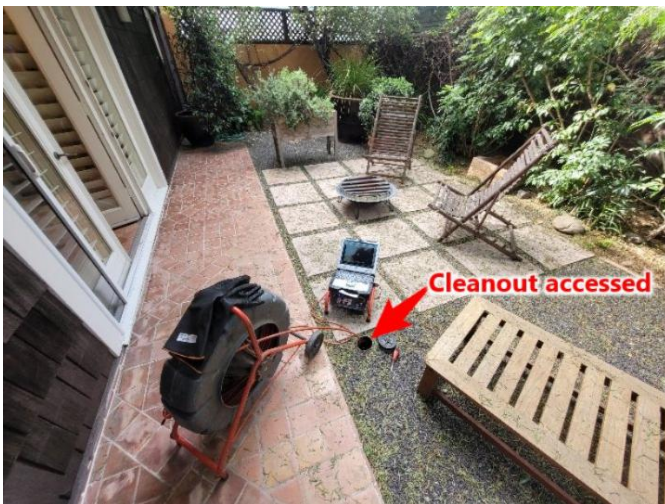
### CLEANOUT LOCATION

The Cleanout accessed was located at the back of the building.

**Note:** The top of the pipe where the Cleanout cap fits over is partially damaged and there was some debris found at the base of the Cleanout. This should be addressed by having the pipe cut below the surface and installing a threaded cap. This will address the potential trip hazard that currently exists and ensure no obstructions fall into the line.

To adjust height of Cleanout / create threaded cap **\$300 - \$400.**

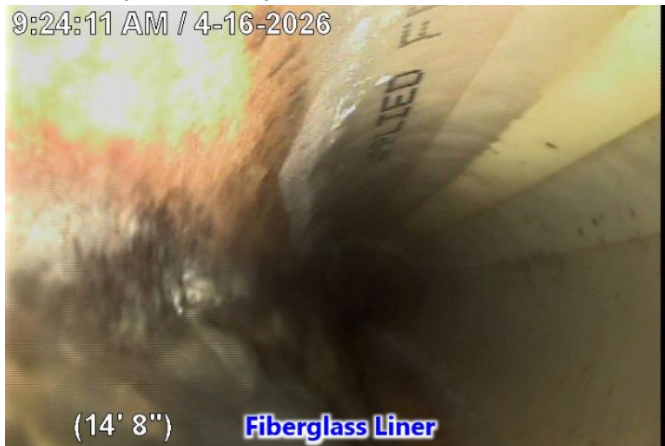
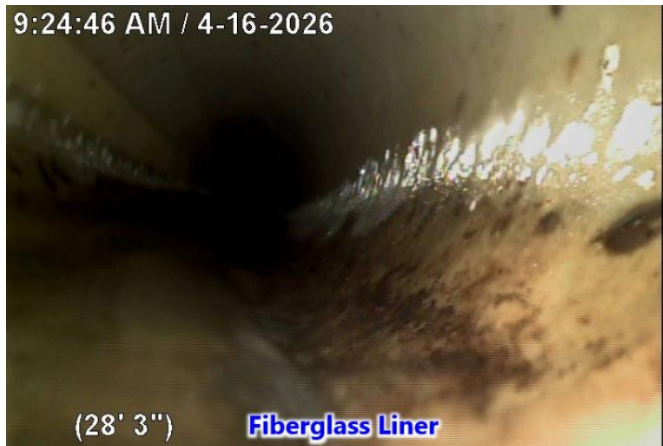
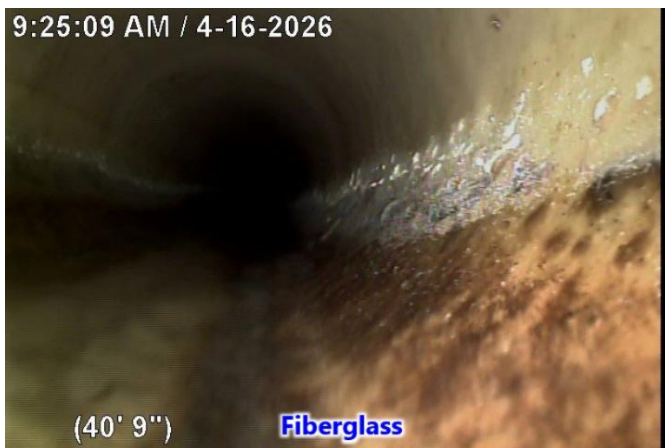
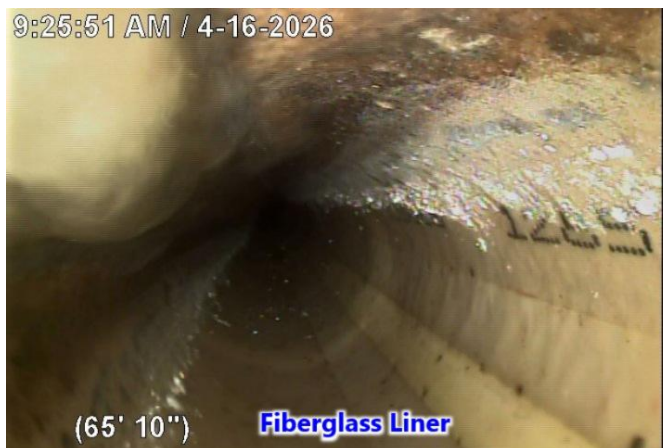
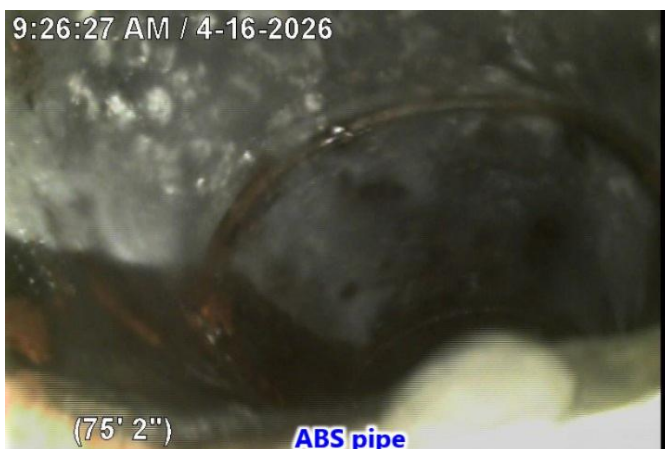
### MAIN SEWER LINE CONDITION

Serviceable overall . No major material defects were observed in the line and waste water was seen to flow freely to the City sewer.

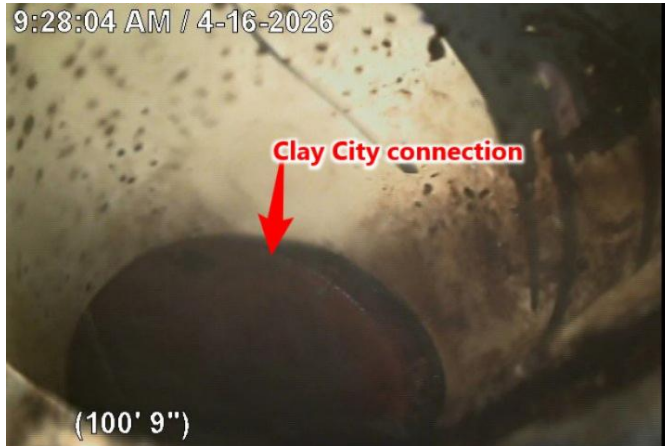
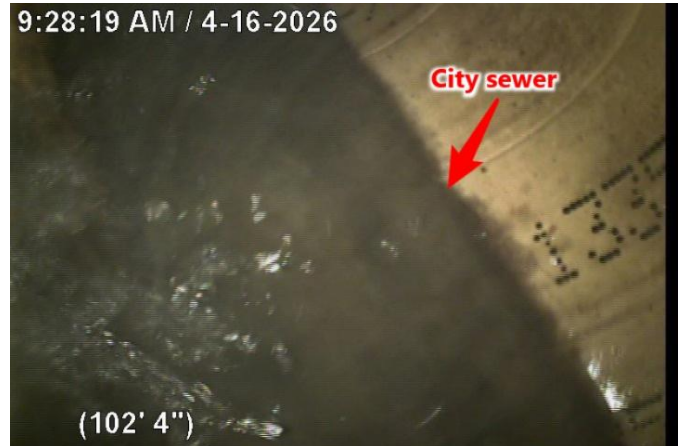
### CITY CONNECTION CONDITION

The City Main connection was located at approximately 102 feet from the Cleanout and appeared serviceable overall with no material defects observed at this time.
