YOUR EEE INSPECTION REPORT

Report: Sample EEE Report **Address:** 9876 Any Street, Glendale

Confidential Exterior Elevated Elements Report

**9876 Any Street
Glendale**

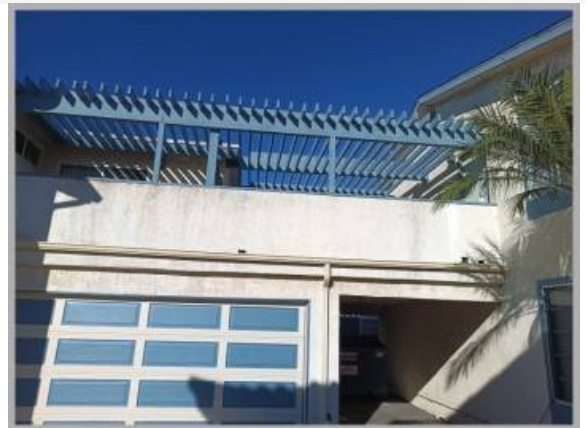
3.6 LOCATION:

Between buildings.

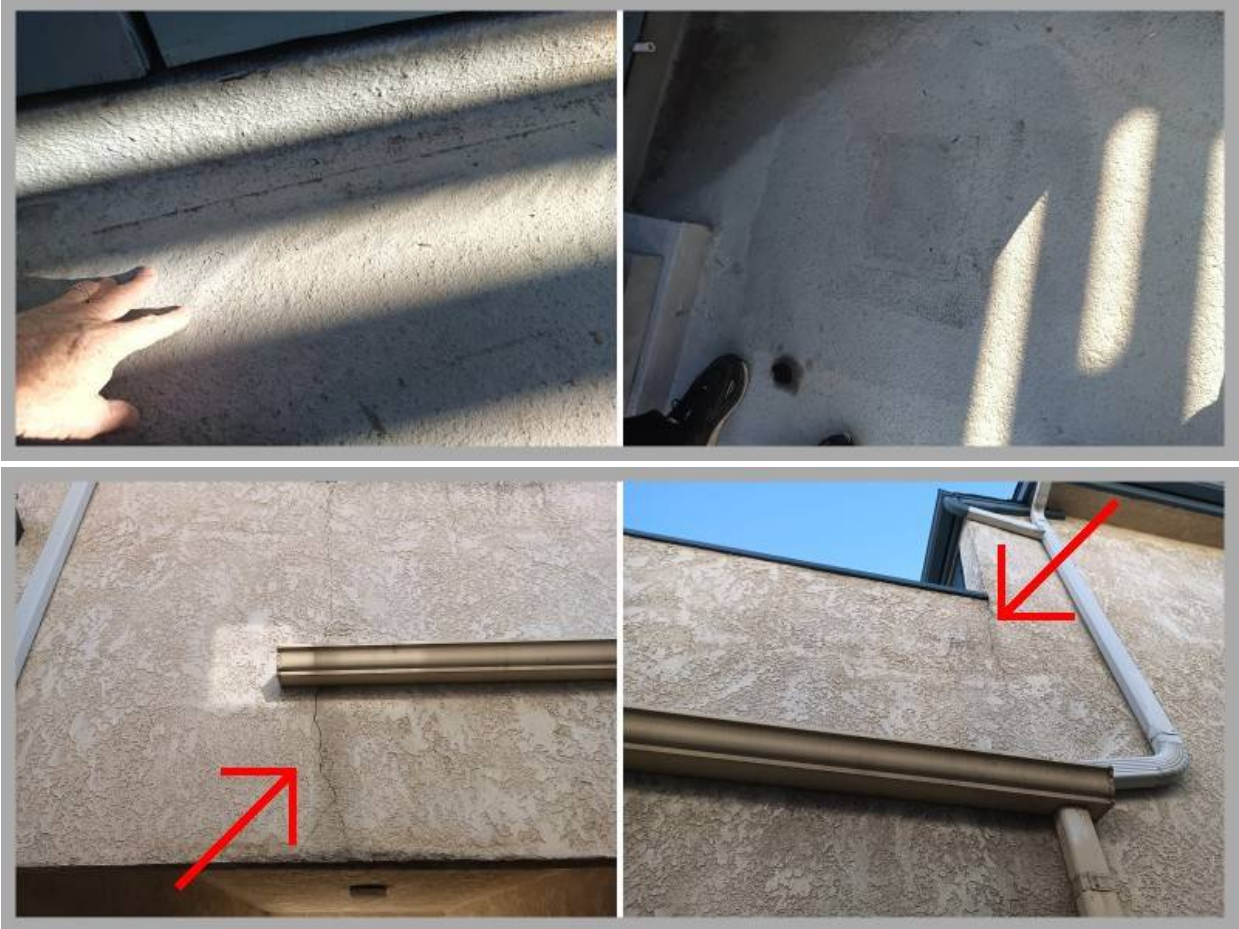
3.7 CONDITION:

M- Some surface wear and blistering due to age and use. Repairs in at least two locations from prior leak. Two

notable vertical stucco cracks at back side. Recoating indicated, fill cracks.

M- Some surface wear and blistering due to age and use. Repairs in at least two locations from prior leak. Two notable vertical stucco cracks at back side. Recoating indicated, fill cracks. \$1,080.00 - \$1,620.00

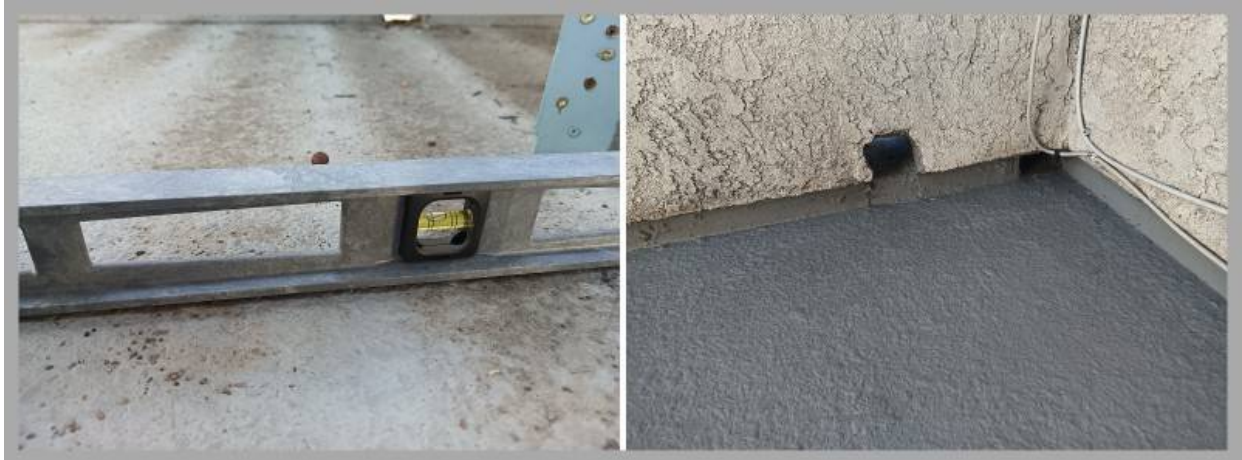
3.8 DRAINAGE:

Satisfactory. Adequate slope noted. Drain scuppers and secondary drain installed.

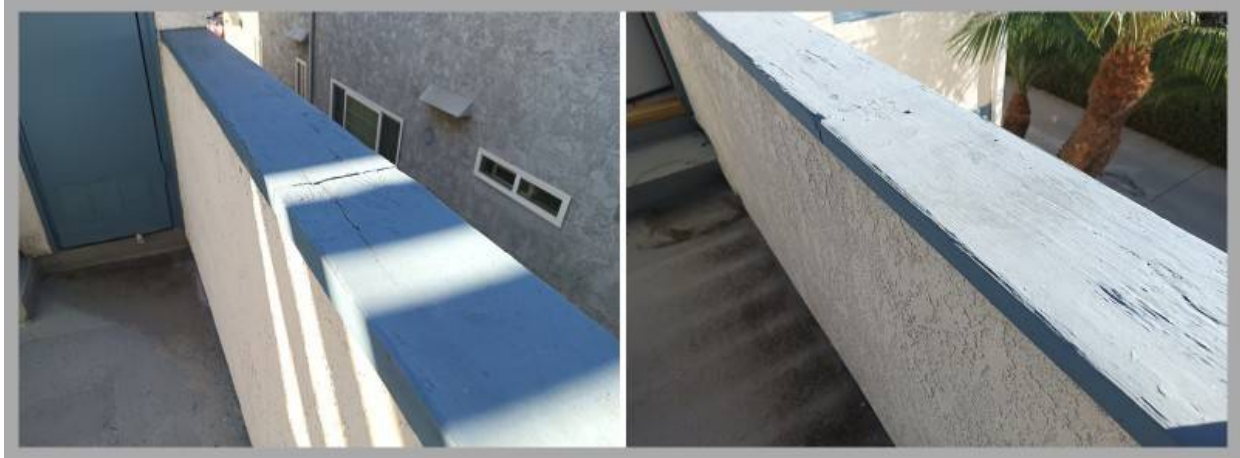
3.9 RAILINGS:

M-Railings are to required standards. Mild wear noted, such as peeling paint. Maintain as needed.

M-Railings are to required standards. Mild wear noted, such as peeling paint. Maintain as needed. \$280.00 - \$420.00

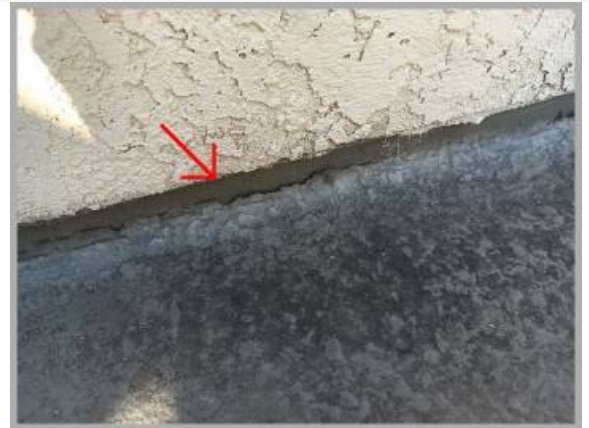
3.10 FLASHINGS:

Some surface material cracking along a section of counter flashing.

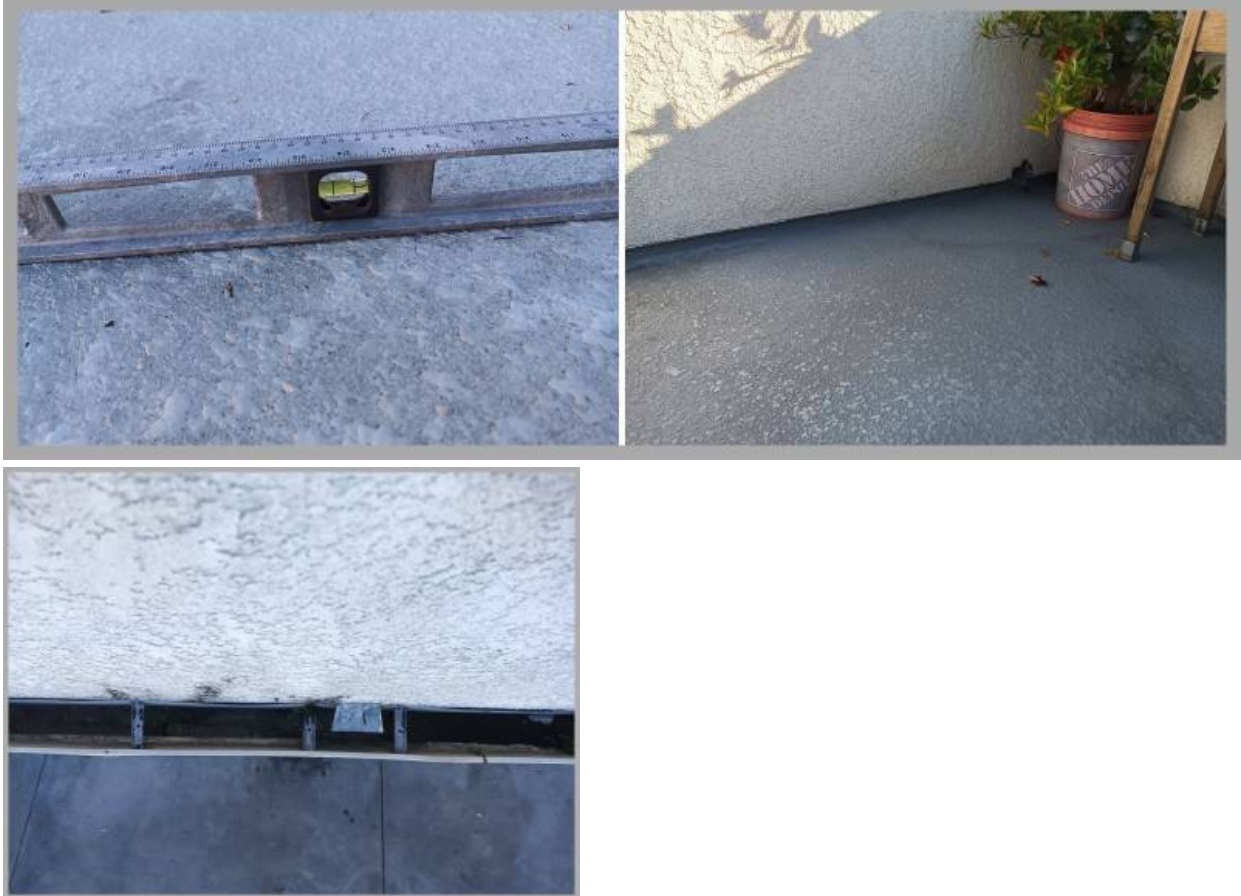
3.14 DRAINAGE:

Satisfactory. Maintain gutter as needed.

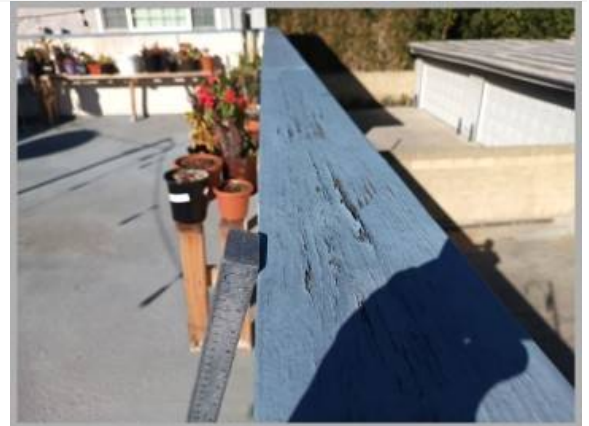
3.15 RAILINGS:

Railings are to the standard height however peeling paint and wear noted. Maintain as needed.

Railings are to the standard height however peeling paint and wear noted. Maintain as needed. \$520.00 - \$780.00
